MACO-PILOT

Sensor material corrosion
investigations and sensor lifetime
estimation

November 2019

RISE Research Institutes of Sweden

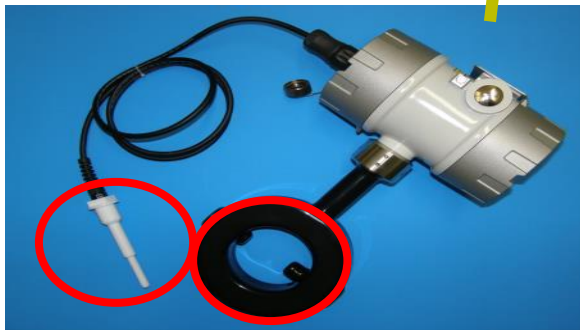
Body: EFTE coated steel
Temp sensor: PTFE

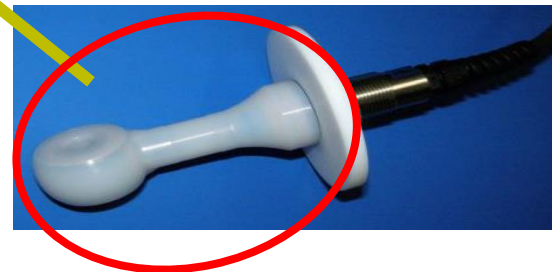
Body: PFA coated steel
Flange: PTFA

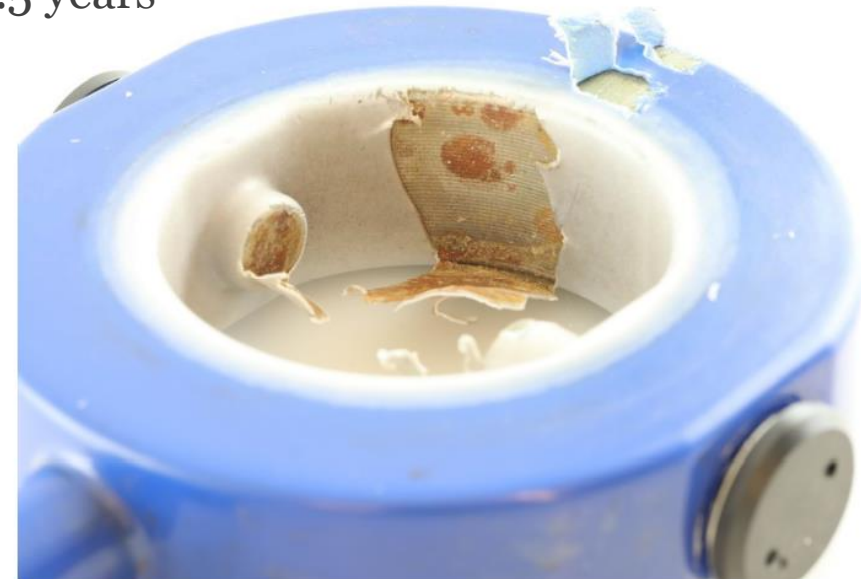
After appr. 3 years in service (mixed acid 65⁰C)
1 mm ECTEF coating

Another sensor with the same coating had a lifetime of 5.5 years

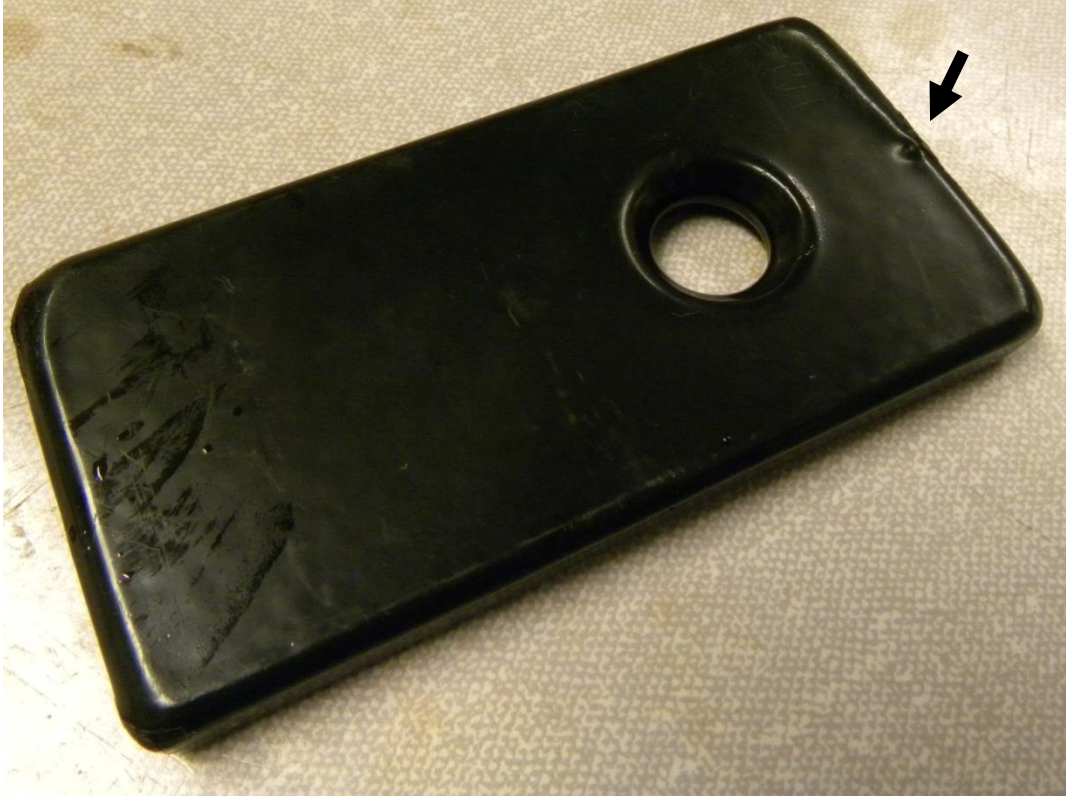
One major difficulty in exposing coated samples to study the diffusion is that there is a risk of penetration through holes in the coating. In this example at the point where it was hanging during the coating process

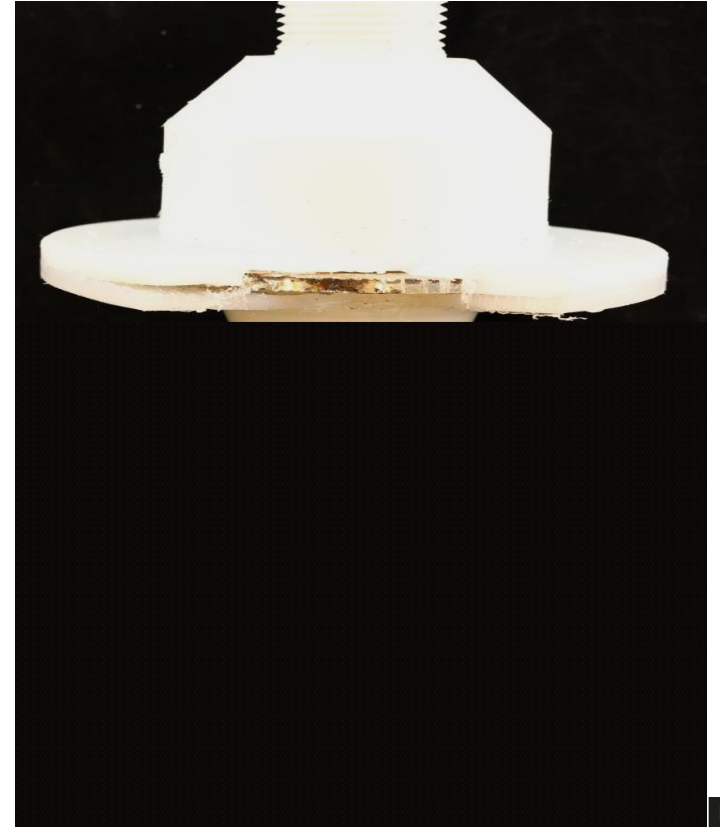
Electrical conductivity sensor

- Moulded into PFA with a top of PTFE
- No corrosion can be found under the thick PFA coating (ca 5 mm)
- Corrosion in the area where the PFA meets the PTFE
- They can be separated fairly easily from each other
- Was solved by moving the joint further away from the acid.

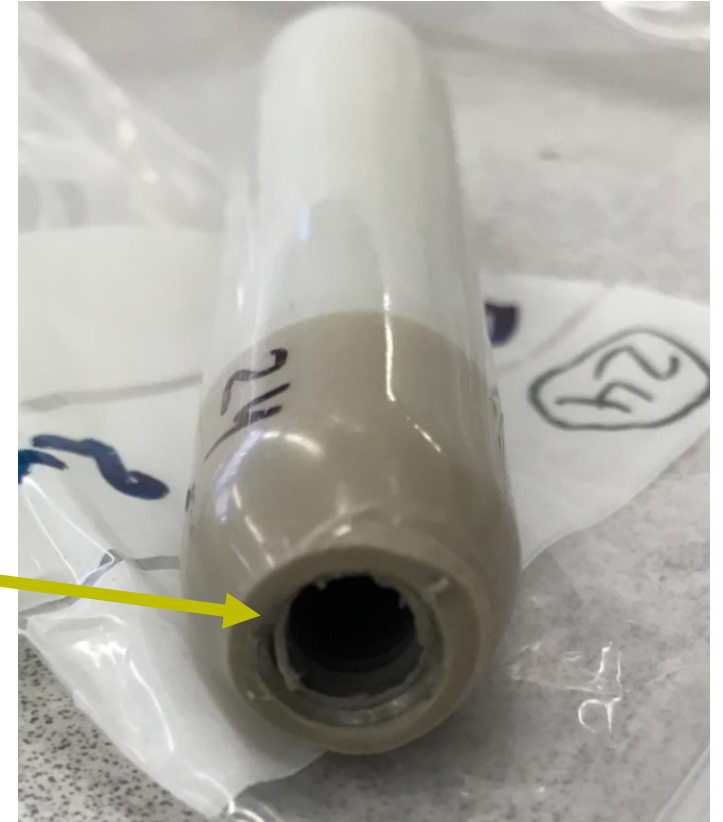
Development of exposure technique

- An important part of the project has been to develop a method to expose steel samples with polymeric coatings
- As the samples are coated, they need to be attached to something, which is why a fully coated samples is difficult and therefore a traditional immersion testing is out of the question.

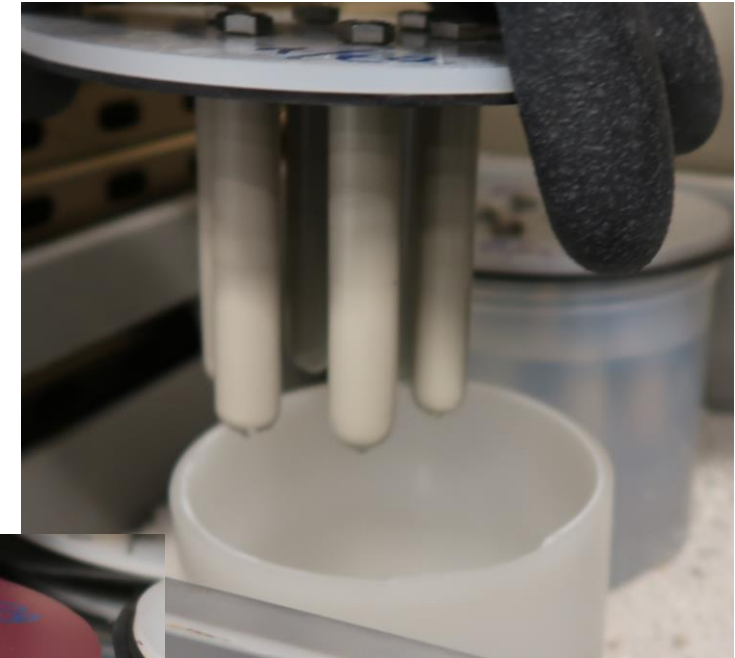
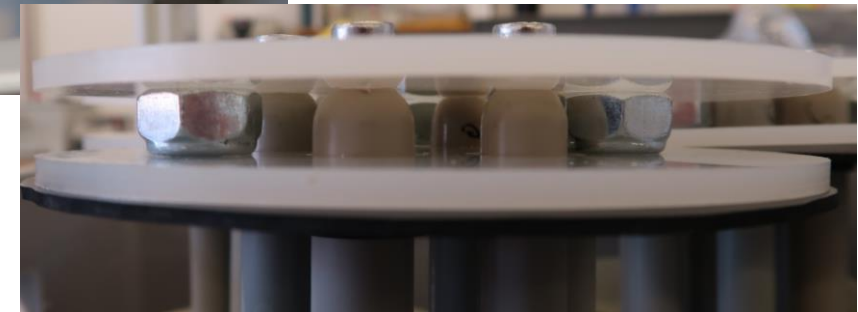
Evolution of exposure containers

- Initially the pins were attached to the lid. This allowed the threading to be above the liquid, but it was still in contact with the gaseous phase.
- By constructing a double lid, where the bottom layer seal the jar so it retains the acid, and the top layer is taking the load, a successful design was achieved.

If acid were to escape from the sealing layer, there is a "ventilation crevice" between the layer, to prevent the acid from entering the threading.

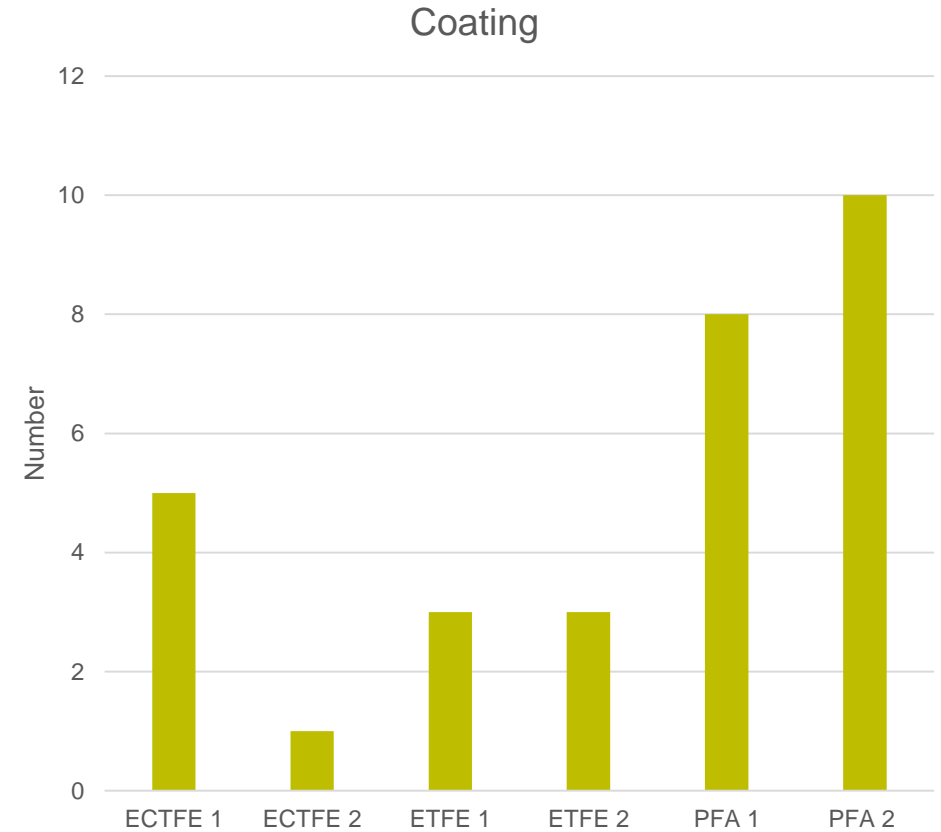
Distribution of the delaminated pins - Coating

- 6/30 (20%) ECTFE
- 6/30 (20%) ETFE
- 18/30 (60%) PFA
- 16/30 (53%) 1 mm
- 14/30 (47%) 2 mm
